Manhole Inspection Summary

Manhole # S23CC1030MH

Insp Date: **7/11/07 10:13 AM**

Location Address: **1503 UNION AVE**

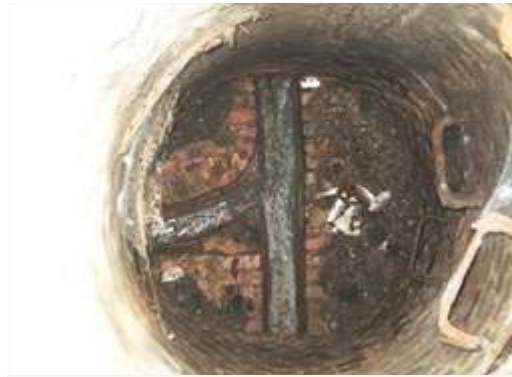
Top View

☒ **Debris** (not Condition related)

Missing: **1**

☒ **Corroded**

☒ **Evidence Of Surcharge**

Corroded and missing steps. Evidence of surcharge - Bench debris.

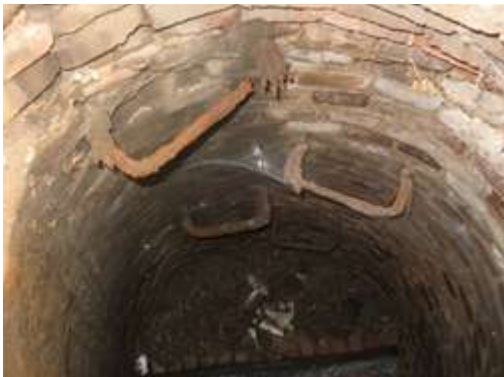
Defect

Frame leaks. Adjustment deterioration and infiltration. Corbel deterioration and infiltration. Barrel infiltration - other side.

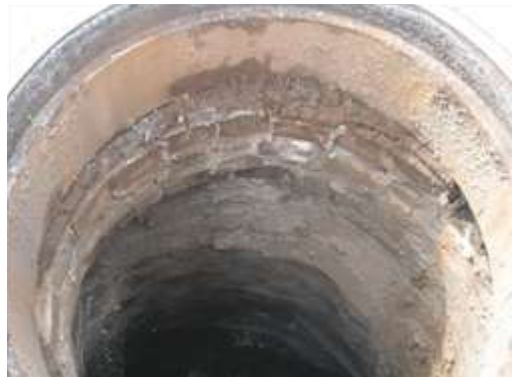
Defect

Frame leaks. Adjustment deterioration and infiltration. Corbel and Barrel infiltration.

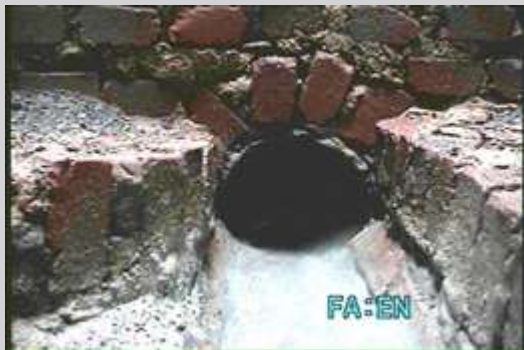
8 in. Circular Gravity Sewer Pipe Out @ 12 O'Clock

Barrel deterioration and infiltration.

Infiltration: **Evidence** Pipe Seal Cond: **Cracked**

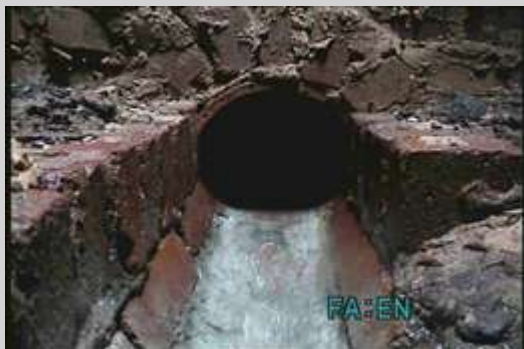
8 in. Circular Gravity Sewer Pipe In @ 6 O'Clock

Channel deterioration.

Infiltration: **None** Pipe Seal Cond: **Cracked**

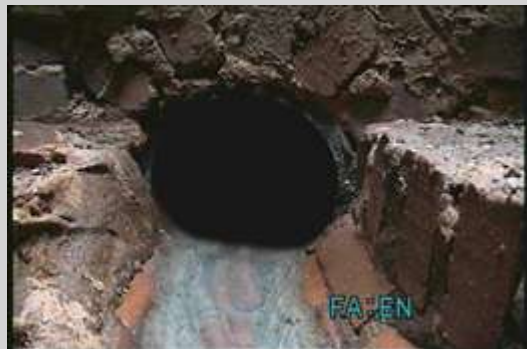
Pipe In @ 9 O'Clock

Infiltration: **Evidence**

Pipe Seal Cond: **Cracked**
